DOE/NASA/0307-1
NASA CR-175058

Improved Piston Ring Materials for 650°C Service

William D. Bjorndahl
TRW Space & Technology Group
Energy Division

March 1986

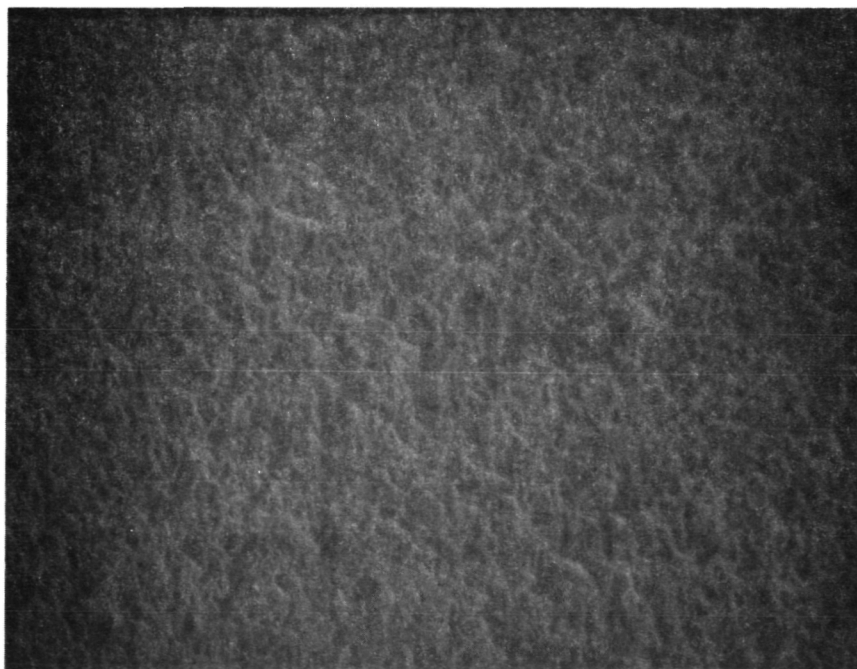
Figure 7.4. Photomicrograph of One of the Poorer Graded Alumina Coatings as Wear Tested Against a Tungsten Carbide Cylinder Sleeve.

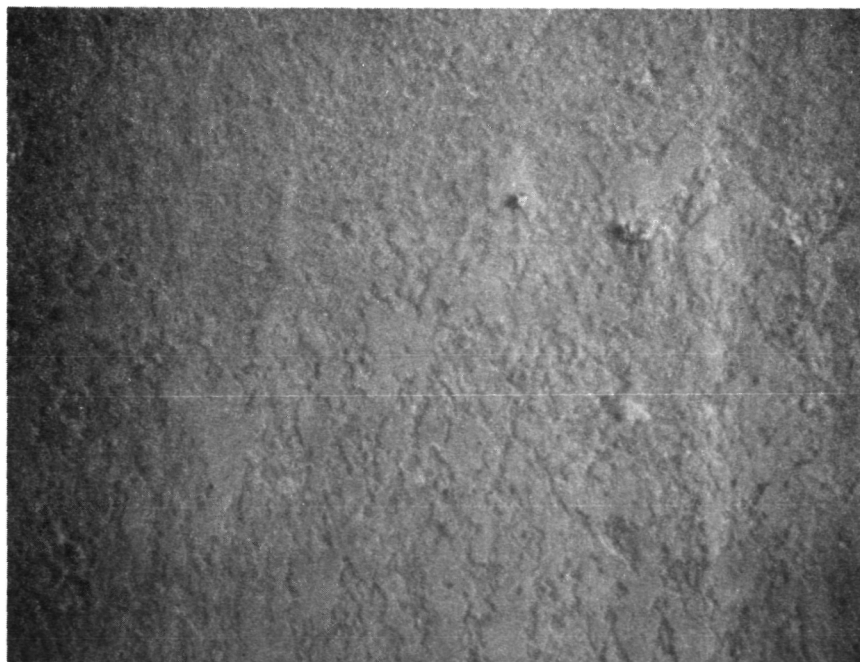
Figure 7.6. Photomicrograph of One of the Poorer Non Graded $\text{ZrO}_2/28.5\text{-}35\text{TiO}_2/2\text{-}4 \text{ Y}_2\text{O}_3$ Coatings After Wear Testing Against a Tungsten Carbide Cylinder Sleeve. This Coating Performed Poorly in Thermal Shock Testing.

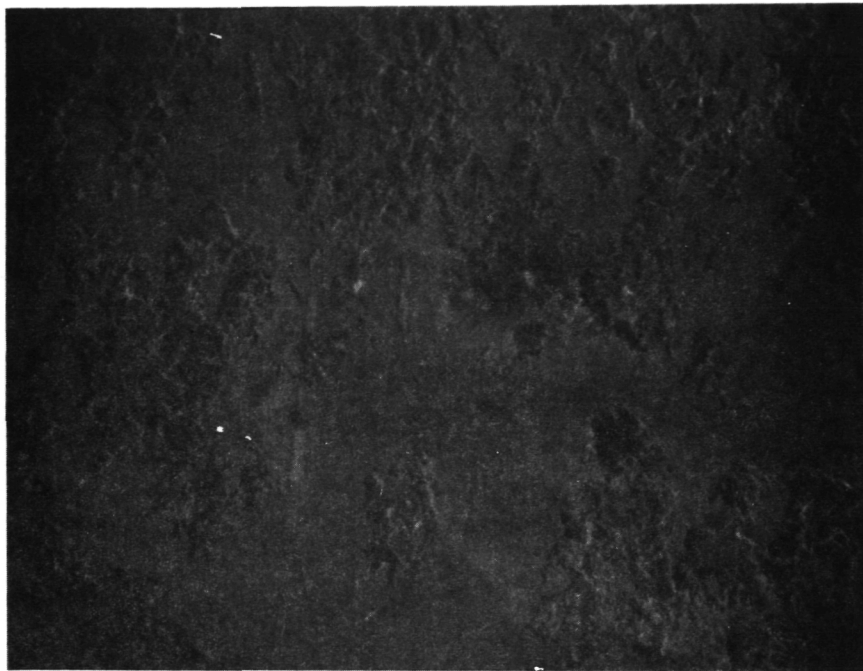
Figure 7.9 Photomicrograph of a Relatively Poor Portion of an $\text{Al}_2\text{O}_3/\text{ZrO}_2/\text{TiO}_2/\text{Y}_2\text{O}_3$ Ring Coating. This Coating is on the Same Ring as the Coating in Figure 7.10.

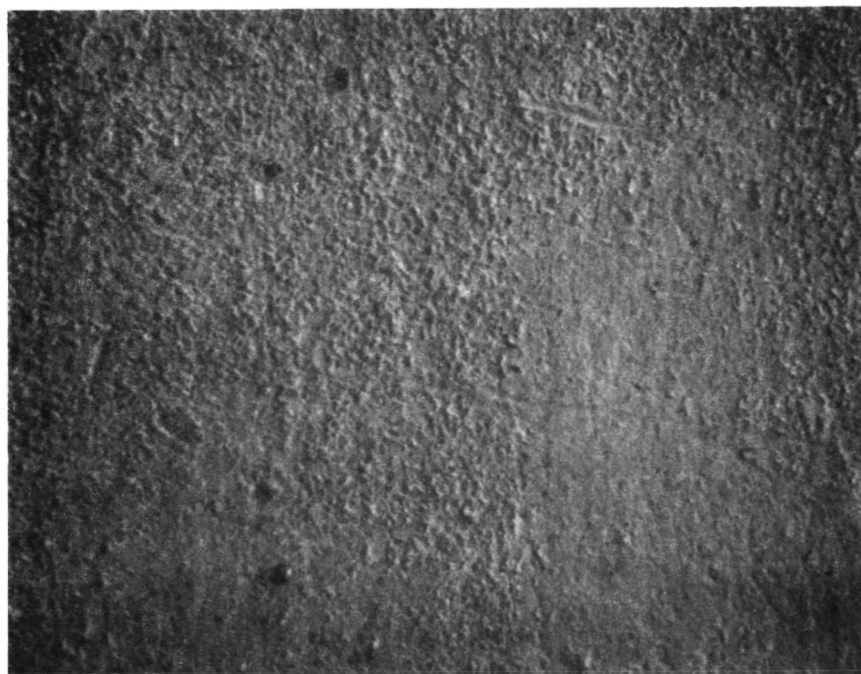
Figure 7.13. Photomicrograph of Molybdenum Based Plasma Transfer Arc Coating After Wear Testing Against a Si_3N_4 Cylinder Sleeve.

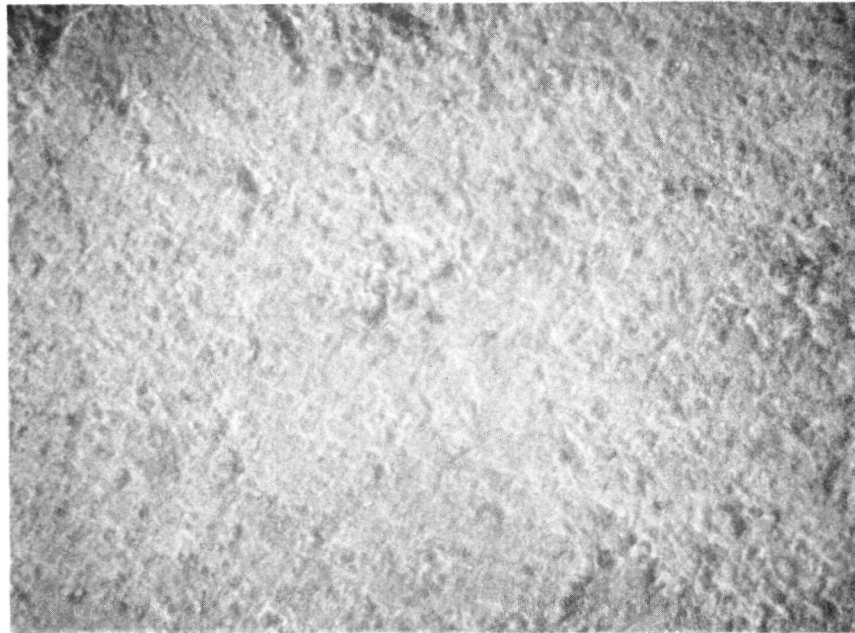
Figure 7.14. Photomicrograph of One of the Better Graded $ZrO_2/TiO_2/Y_2O_3$ Coatings as Wear Tested Against a Tungsten Carbide Cylinder Sleeve. This Coating performed poorly in Thermal Shock Testing.

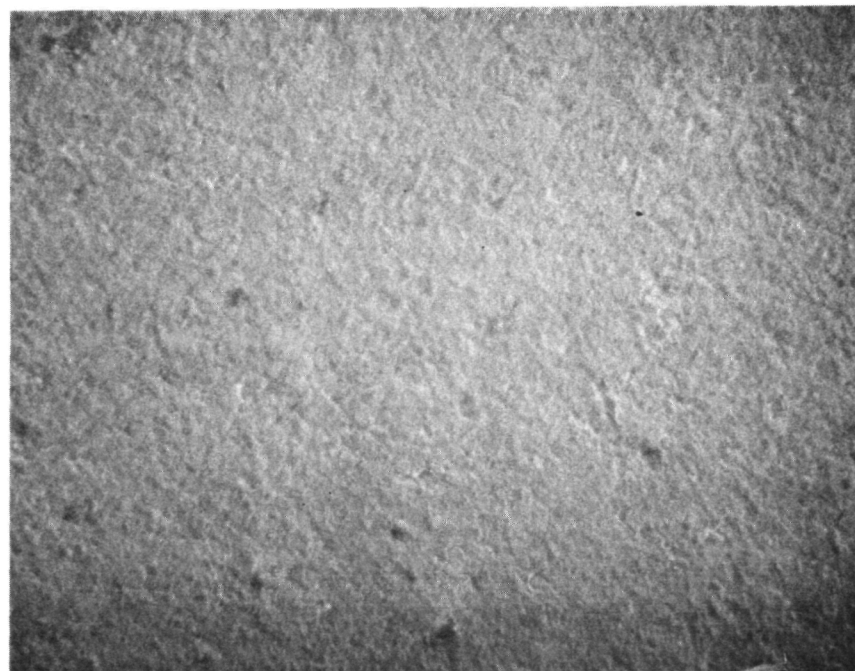
Figure 7.15 Photomicrograph of One of the Poorer Graded $ZrO_2/TiO_2/Y_2O_3$ Coatings as Wear Tested Against a Tungsten Carbide Cylinder Sleeve.
